THE CHAPEL ON BLAKENEY EYE : INITIAL RESULTS OF FIELD SURVEYS

By Peter Carnell

During the winter of 1998/99 the BAHS undertook a detailed study of the 'chapel' ruins on Blakeney Eye, using a variety of survey techniques. Some useful information has been obtained and the first results are outlined in this article. Other reports will be prepared in due course after further analysis of the information obtained. This article describes the principal surveys: height measurements, geophysics and molehill sampling. A separate article in this issue of the Journal outlines what is known about the site from documentary sources.

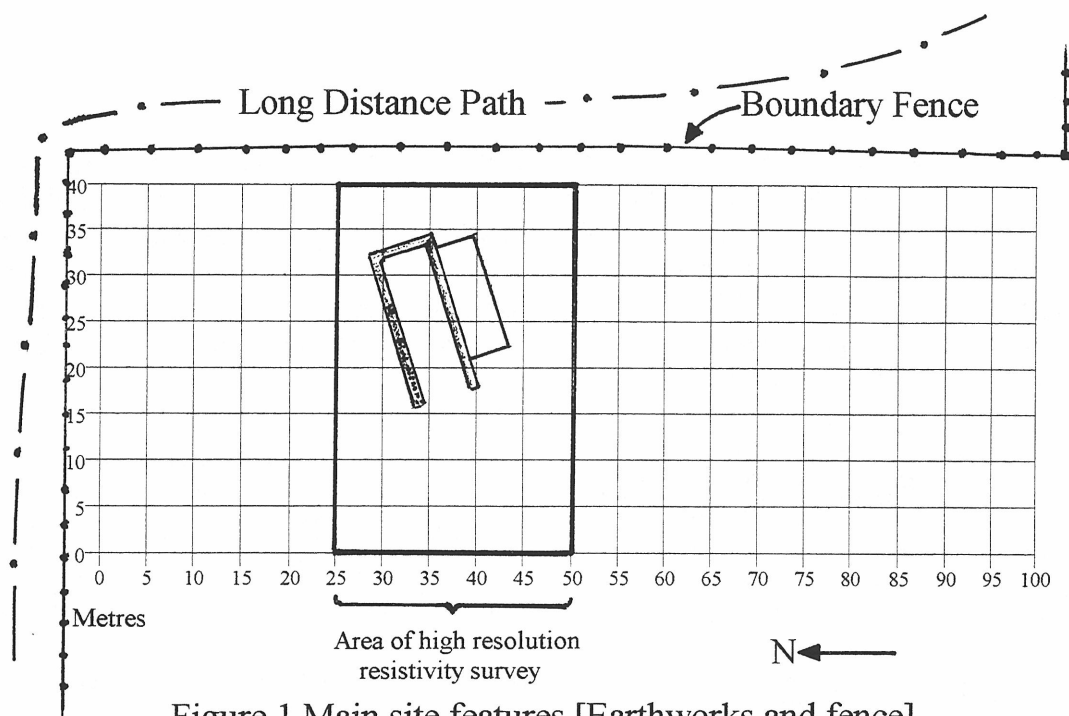
Figure 1 Main site features [Earthworks and fence]

Fieldwork was carried out on at least one day each week between January and May 1999, with between three and eight people on site at any one time. The selected survey area measured 100 by 40 metres, being the largest that could be covered within the time and resources likely to be available. The area occupied the extreme north-east corner of the Eye and was closely bounded by a post and wire fence beyond which lay the seabank carrying the coastal footpath. (Fig. 1).

Four measured surveys were conducted: height, resistivity, magnetometer and molehill sampling. They were preceded by a visual survey to record the main features of the site, principally the flint and mortar remains, the main ridges and depressions, and various grass marks. All survey measurements were entered into computer programs to produce distribution plots and other data.

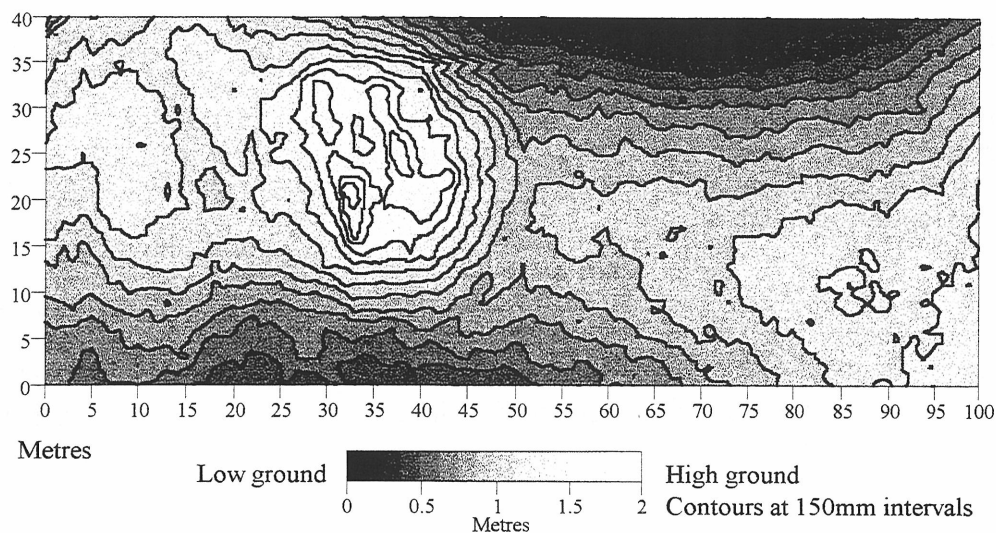
Figure 2. Height contour map .

Heights were measured from an arbitrary datum level at one-metre intervals over the survey area, 4141 measurements in all. Figure 2 shows relative heights across the site at vertical intervals of 15 cms (6 inches). The chapel building stands on the highest point of the surveyed area. On three sides the land surface slopes down immediately and quite steeply; towards the north the slope is more gentle and a 'channel' appears to cut across a 'plateau' area. From the chapel area a ridge leads southwards, rising towards another knoll just outside the survey area. The chapel and the second knoll form the two highest points on the whole of the Eye.

The contour and resistivity maps (Figs 2 & 3) show less correspondence than might have been expected. A thin soil developed on sand and gravel tends to be drier in the higher areas and wetter in the lower areas. With the notable exception of the chapel site, however, the reverse is often the case on the Eye: the low ground to the north-west, for example, is much drier than the relatively high ground to the south-west. The flat area to the north of the chapel has relatively constant resistivity; by contrast there is a rectangular area of drier ground south of the chapel, which has little correlation with the contour map.

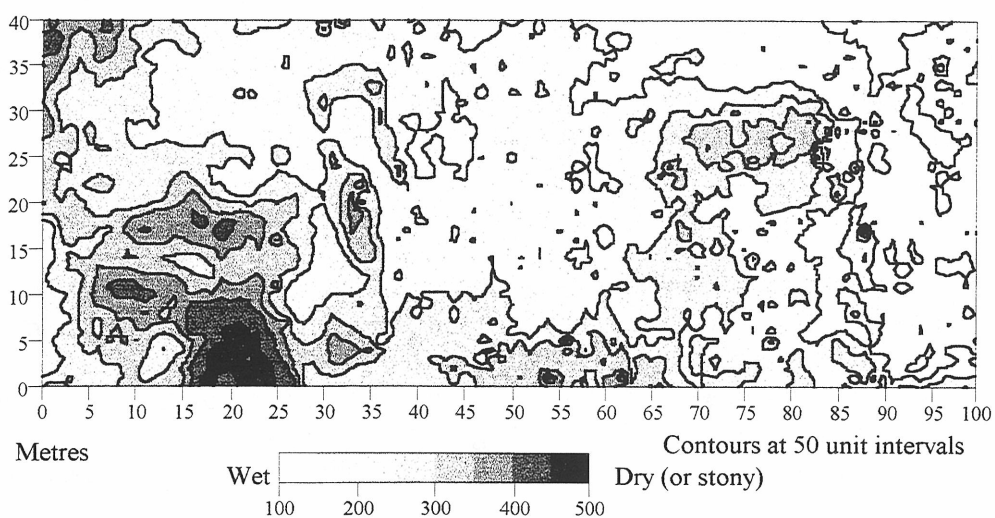
Figure 3. Resistivity survey [1 metre intervals]

Resistivity is a method of measuring the ability of the soil to conduct electricity and the resultant maps, in effect, show the amount of moisture in the soil. Measurements were taken with a purpose-built meter and a frame with two probes attached. Two sets of readings were obtained: one over the whole site at one-metre intervals, and one in the immediate area of the chapel at half-metre intervals (4131 readings). The main survey was conducted on three successive Fridays and the initial results showed the effects of changing weather conditions.

Adjusted readings (Fig. 3) show the larger of the two cells that make up the building, but the smaller cell to the south is almost imperceptible. The wettest areas are within and immediately outside the smaller cell, and in the south-eastern sector of the surveyed area. The driest areas are mostly to the north-west.

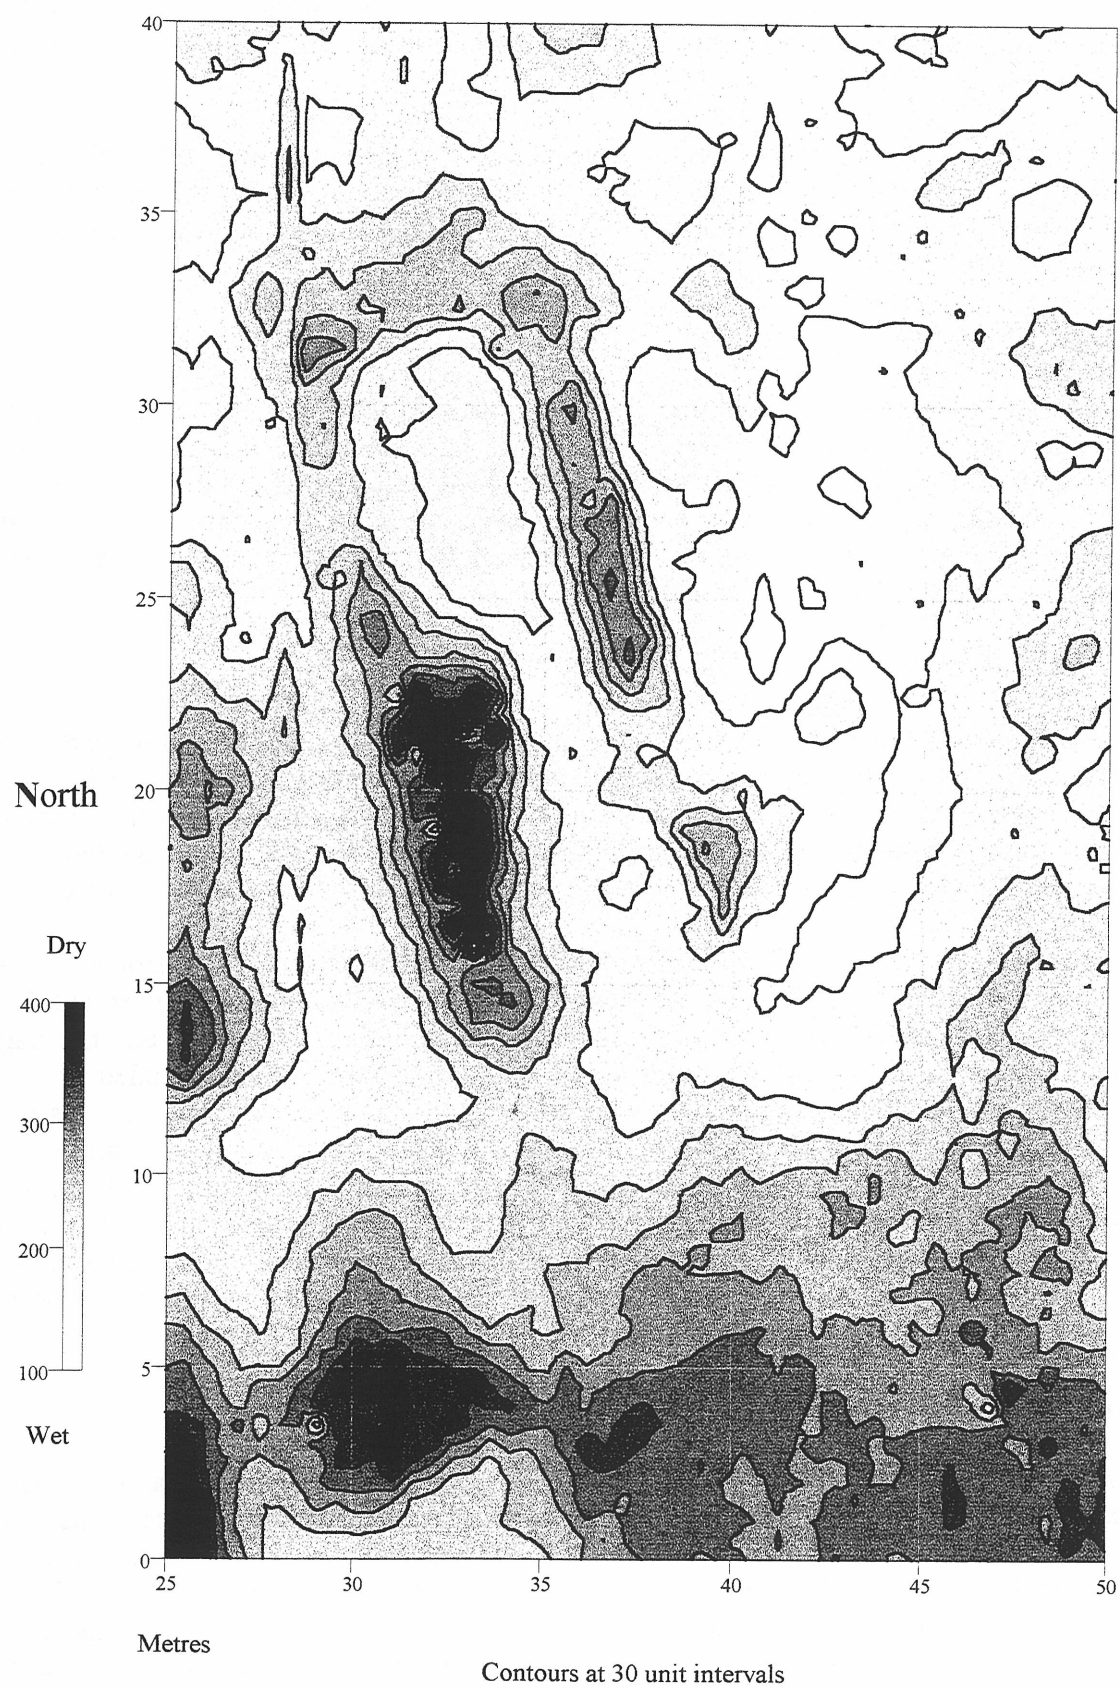
Figure 4. High resolution Iso-resistivity map of the chapel site.

The high resolution resistivity survey (Fig. 4) shows clearly the earthwork which constitutes the larger of the two cells, with the driest (darkest) area indicating the visible stonework. There are only traces of the smaller of the two rooms, even though little such distinction is visible to the eye

The high resolution resistivity plan shows in dramatic fashion the difference between the two cells of the chapel. The larger, more northerly, one shows up strongly, the smaller one hardly at all. Such a difference is very likely to indicate that the foundations of the larger room are much more substantial than the other, even though this is not apparent from the surface appearance. It might be that the walls of the smaller room have been much more thoroughly robbed of their stonework, but this is unlikely as the form of the ruins – wall fragments showing through the banks of a low earthwork – is essentially the same for both. The most likely conclusion is that the smaller room was built in a different fashion, perhaps using less flint, which may indicate that it was built at a different time, and perhaps later.

The high resolution resistivity map indicates that the smaller cell has a western end even though the image is faint. There is no sign, however, that the main building had a western wall. Were there ever foundations here? The ground slopes away steeply where the wall should be located and on site it is easy to imagine the sea sweeping away this side of the Eye, taking part of the building with it. Downslope to the north-west is an area of very high resistivity barren of molehills. Could this be the remains of the western wall?

One portion of the stonework looks as if it might be a fallen piece of walling and the resistivity plot does nothing to dispel this. A gap in the dry readings that portray the northern wall might indicate a doorway, which is also indicated by an abrupt change in the visible stonework. There is also a suggestion of an inner division. It is probably pushing interpretation too far to see in Figure 4 an apsidal end to this larger room, and thereby an early church building.

The smaller cell appears to have a division through the middle which co-incides with some brick visible in the grass and in some of the molehills in this area. This brick division might have been a later insertion into the building or ruin – for sheep pens for example. The interior of this room (and to a lesser extent the main cell) is relatively damp which could possibly indicate water trapped above a buried floor.

From the high resolution resistivity map it can be seen that there is a clear break in the southern wall. By comparing the building outline (separate overlay) with the magnetometer map (Fig. 5) it can be seen that the metal fence cuts through the wall at this point. It would appear that the wartime construction of this fence caused the partial destruction of this southern wall.

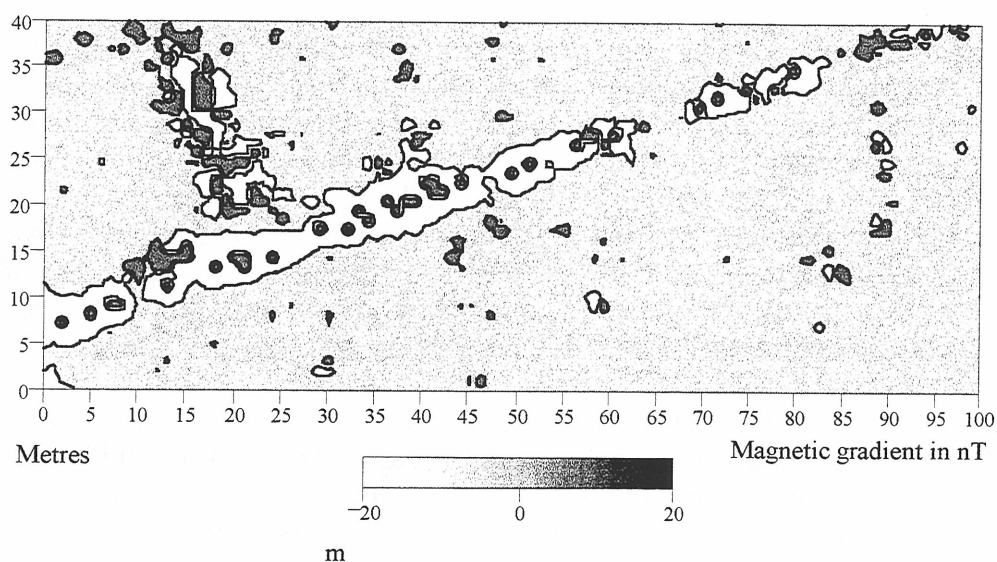
Figure 5. Fluxgate magnetometer survey

A fluxgate magnetometer was used to record small variations in the earth's magnetic field over the site. Readings were taken at one-metre intervals (4000 measurements) and a map produced (Fig. 5). There is no indication of the chapel building but a totally unexpected result is the straight line of very strong anomalies, with another line or patch of similar readings at right angles to it. These readings were compatible with buried ironwork and were later identified as part of the wartime defences.

The strong features of the magnetometer map can only be the result of buried metal objects, and it is very likely that they are the bottom parts of sawn-off metal posts that once formed part of a wartime metal (barbed wire) fence. The line of anomalies joins the seabank immediately to the north of the survey area and close by, sticking out of the path that runs along the embankment, are pieces of angle-iron which gave the same readings as those within the survey area. There are also other similar readings along the path at points where iron is not actually visible at the surface. The other end of the line across the chapel joins the path to the south-east of the survey area where the embankment is at a similar height to that at the northern end. Those who put the fence up appear to have cut off the north-eastern corner of the site, where the seabank is at a lower level, so that the fence could be kept on relatively high, level, ground.

The other anomaly is at right angles to the fence but does not connect with it. The feature is wider than the fence and (unless it is a fence re-positioned more than once) could represent pits containing metal – perhaps barbed wire.

- The remnants of walling that can be seen at the surface probably constitute the whole building – there is no clear evidence that any extension exists which is not now visible. A narrow ‘wall’ running southwards from the chapel, reported by local residents in the 1970s, might have been parch marks associated with the wartime fence found by the magnetometer.

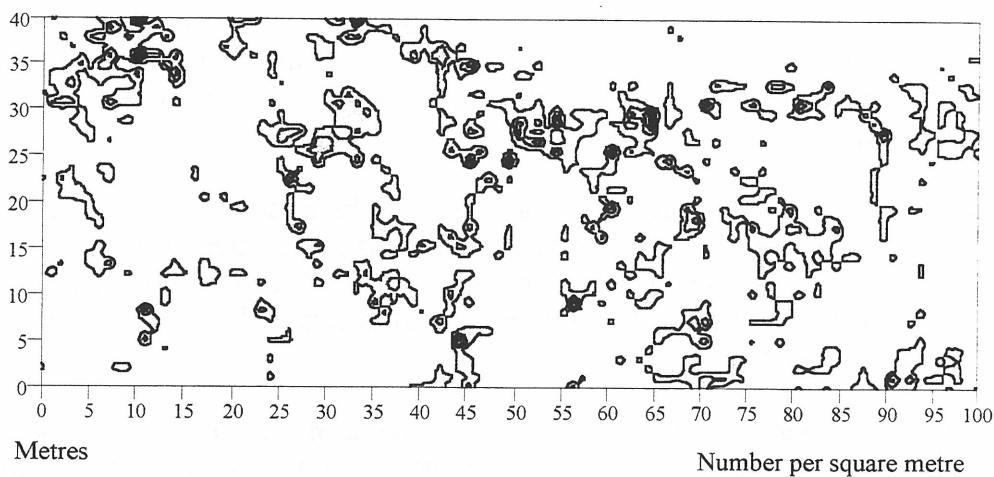
Figure 6. Molehill distribution

The survey area was covered with clusters of molehills in various states of degradation, and a total of 954 were sampled (Fig. 6). Mole heaps were distributed across the site but with some blank areas which may be there for physical or archaeological reasons, or just by chance. From each heap a sample of 750 millilitres was sieved and the finds counted and (later) weighed. The remainder of each heap was checked visually for any unusual artefacts.

The distribution of molehills (Fig. 6) makes interesting comparisons with other maps. In a soil with constant characteristics the distribution might be random, but it is not entirely random on the Eye. There are no heaps within the smaller building, which has no obvious doorway, but there are within the larger, which tends to confirm that the open western end has no solid barrier below ground. Molehills generally avoid the area of buried wire, if that is what it is, and also the low, wet ground to the south-east as well as the dry, low ground to the north-west. Neither are there many on the wetter, but higher, ground to the south. If there is any direct relationship with resistivity then it is that mole heaps are more likely to occur in *average* moisture conditions.

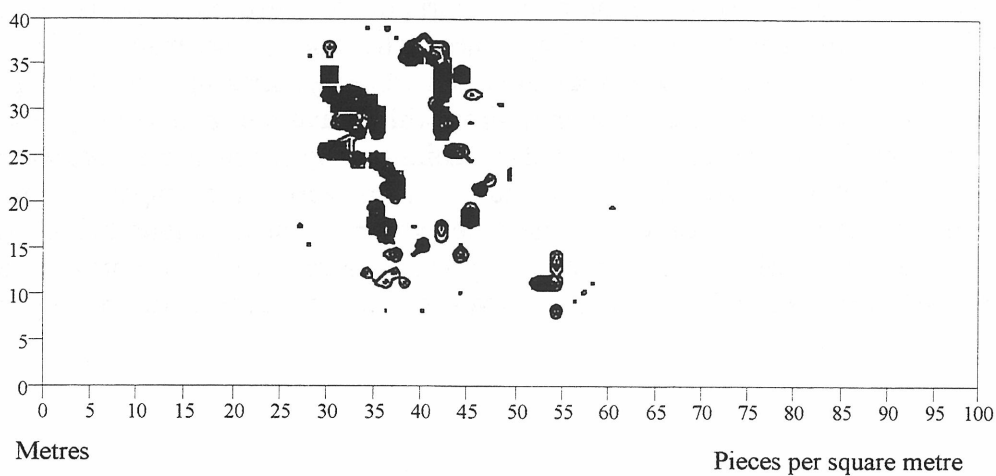
Figure 7. Molehill survey: mortar

Maps were produced showing the distribution of the main finds: mortar, stones with mortar, seashells and slate (Figs 7 – 10). All these finds were heavily concentrated around the chapel building. Not illustrated, but with broadly similar distributions were brick and tile fragments, small pieces of coal or clinker, and a few metal fragments which included five wartime bullets. Only three pieces of pottery were found, none appeared to be as early as medieval. The weight of stones (without mortar attached) was also mapped and was found to be heavily concentrated around and to the south of the chapel: the area to the north produced very few. None of the stones were noticeably water-rolled as they would have been had they come from the beach; they appeared to have come from glacial deposits. A scatter of small pieces of chalk was also discerned; these are probably agricultural in origin, but might also be a natural component of the underlying gravel deposits.

Mortar fragments and flints with mortar attached (Figs 7 & 8) are found only in the immediate vicinity of the chapel building, principally within the larger building and to the east of the smaller one. Stones with mortar had the additional emphasis that they were found particularly in the vicinity of the 'west wall' which might possibly encourage the view that such a wall has been destroyed than that it never existed. The inescapable conclusion is that these mortar pieces have come from the walls of the building either during robbing activities or as products of natural weathering or accidental erosion (by cattle, for instance). The remnants appear to be similar to the material of the wall tops visible at ground level. The flints associated with the wall, either in it or nearby, are not typical beach-rounded stones, and some are very large. Perhaps all the walls were robbed to ground level at the time but there has been some further erosion at the western end of the north wall since then, leaving a few stones proud of the surface.

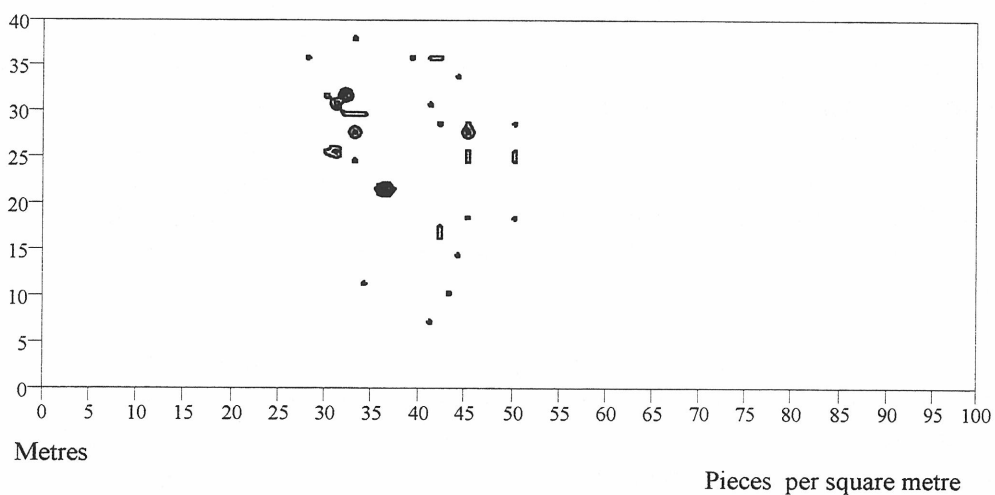
Figure 9. Molehill survey: Sea shells.

Seashells (Fig 9) were few but had essentially the same distribution as the mortar, which probably indicates that these shells were once part of the fabric of the building – indeed, one or two can still be seen in situ in the wall where they would have been used to strengthen the mortar. It is notable that no shells were found away from the building.

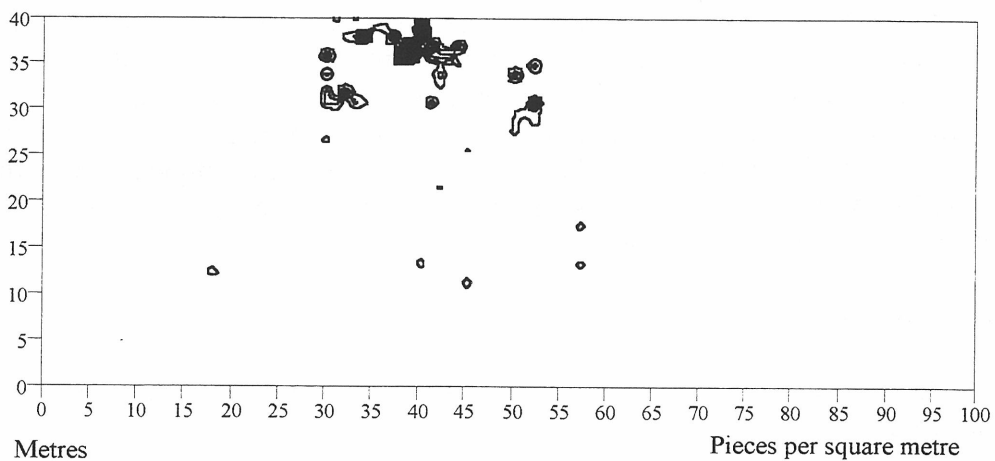
Figure 10. Molehill survey: slate

The slate fragments found, none larger than a 50p piece, were also associated with the building (Fig. 10) but the distribution was clearly different from the other building materials. Apart from a few pieces just inside the larger building, the slate was concentrated outside the south-eastern corner of the smaller cell. This suggests that roofing slate was stacked there for removal and that the present distribution is what remains from breakages. If slate was used to roof the building then it was unusual, for there is little slate in local villages and there would have been even less before the arrival of the railways. The chapel is described in documents as 'ruined' from around 1600 onwards and there is no evidence that it was ever rebuilt in relatively recent times. In the medieval period it was only religious and other important buildings that were roofed in slate as the carriage costs from slate quarries elsewhere in the country would have been very high.

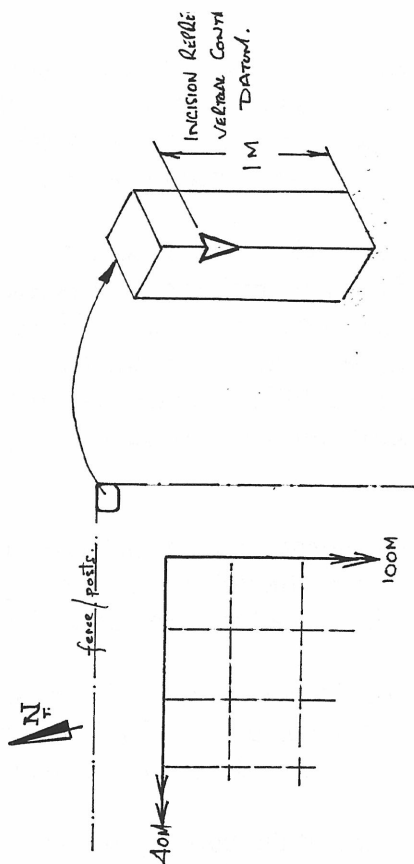
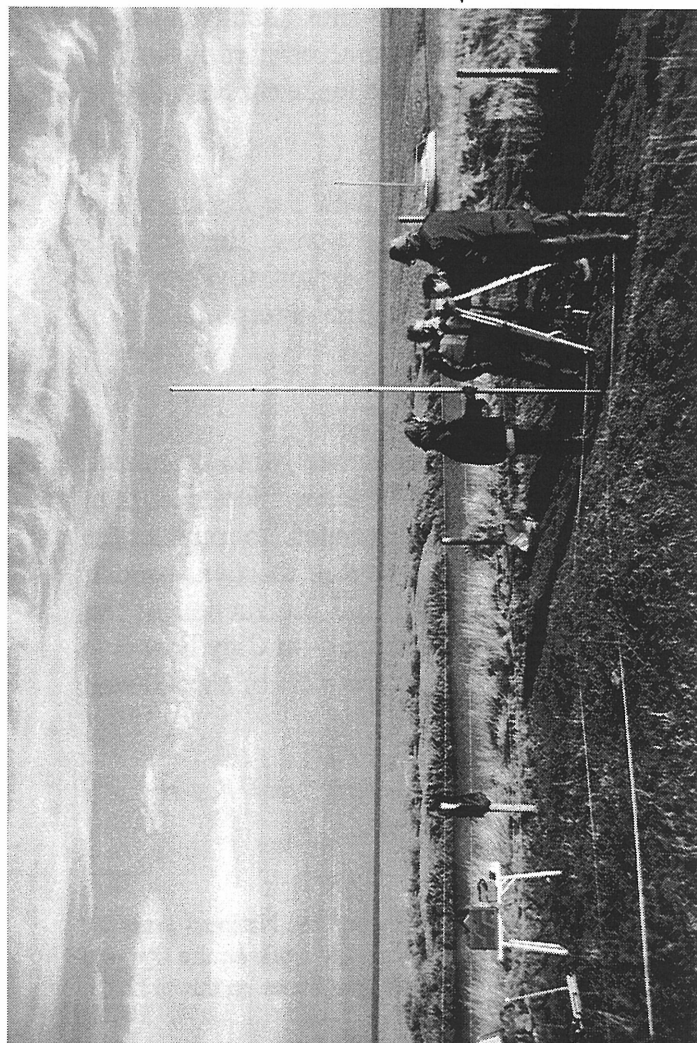
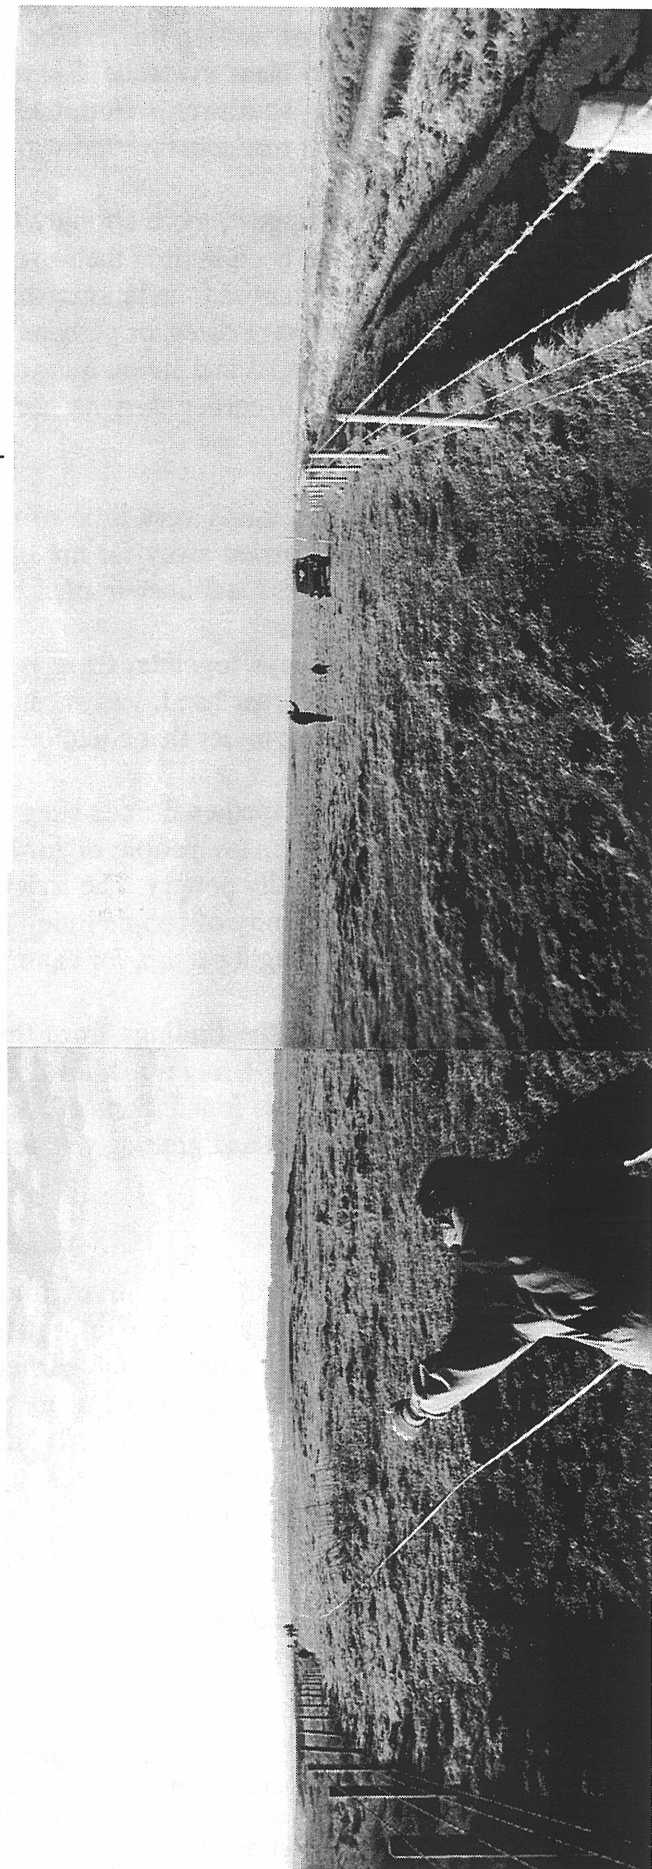
SITE SURVEY---ESTABLISHING GROUND GRID WITH
DATUM IN NORTH EAST CORNER OF FIELD.
(Note prominent mounds of building site and Church)

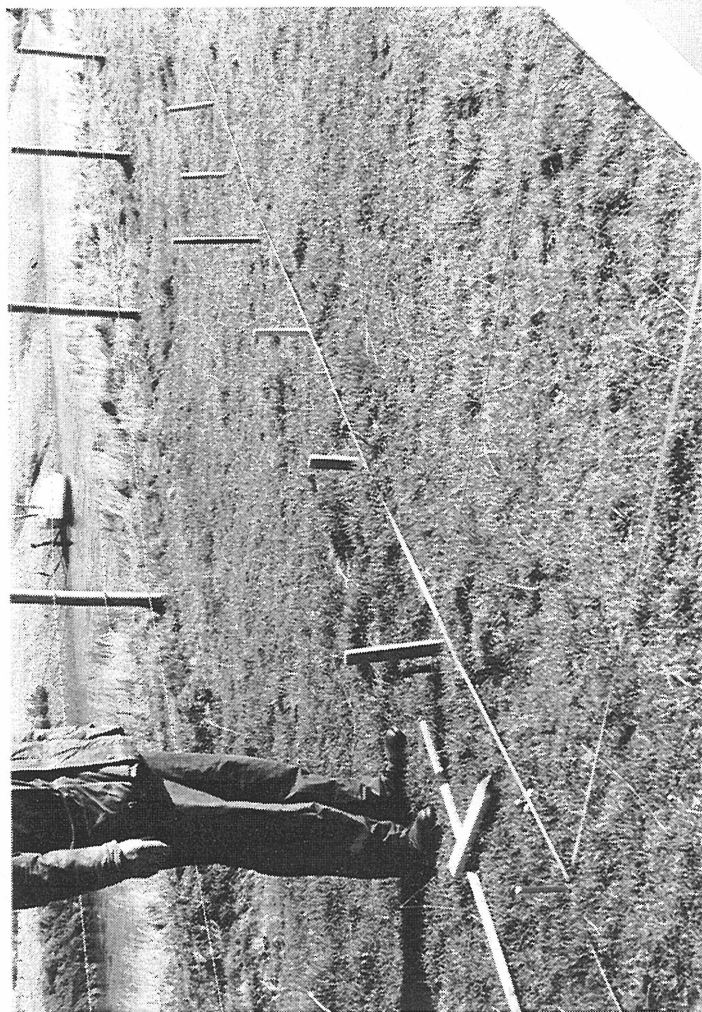
SET-UP FOR EACH 20M x 20M GRID
(Note 8 off sectors on original ground grid)
Red moveable cord for N/S alignment and pegs
at 1M intervals to assist transfer to next traverse

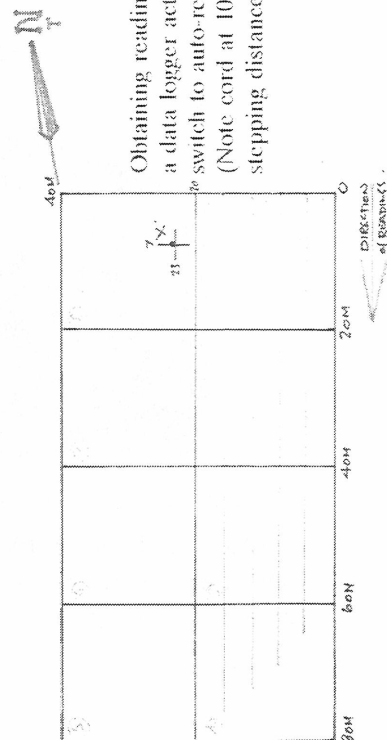
Obtaining readings at 1M steps using
a data logger activated by a hand held
switch to auto-record values
(Note cord at 10M to verify correct
stepping distance at halfway point)

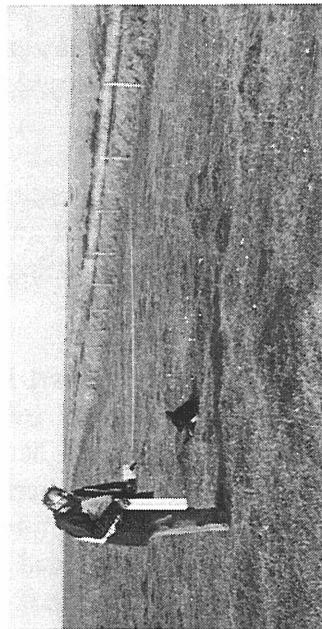
CALIBRATING SCALE AT CONTROL POINT 'X'
