Medieval Walls in a Wiveton Rose Bed

By John Wright

Introduction

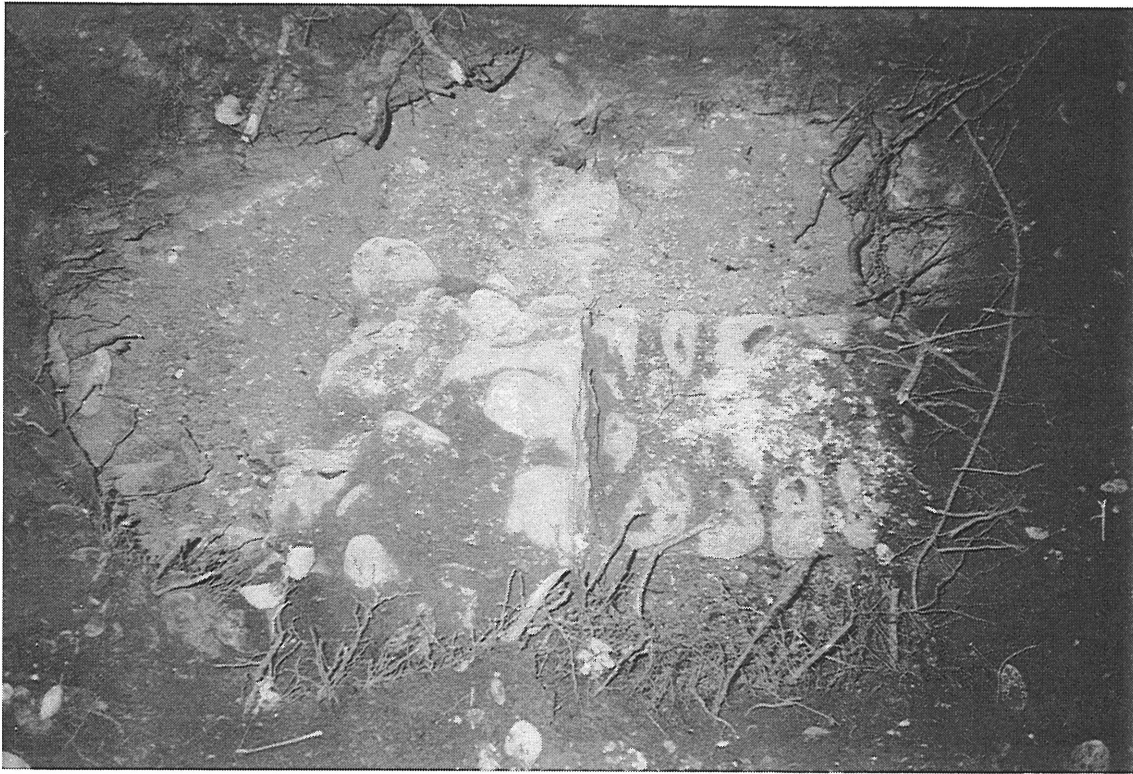
TRENCH 3

Showing outer boundary wall and abutting wall (in a maze of roots)

In Trench 3 the wall appears to represent a continuation of the outer wall seen in Trench 2 although the alignment is very slightly curved (or perhaps angled) rather than straight. The third wall, in Trenches 3 and 4, runs at right angles to the outer wall and butts up against it – there is no bonding at all. At the point of contact the outer wall leans outwards towards the east, and immediately to the south the top of the outer wall drops by some 40 cm.

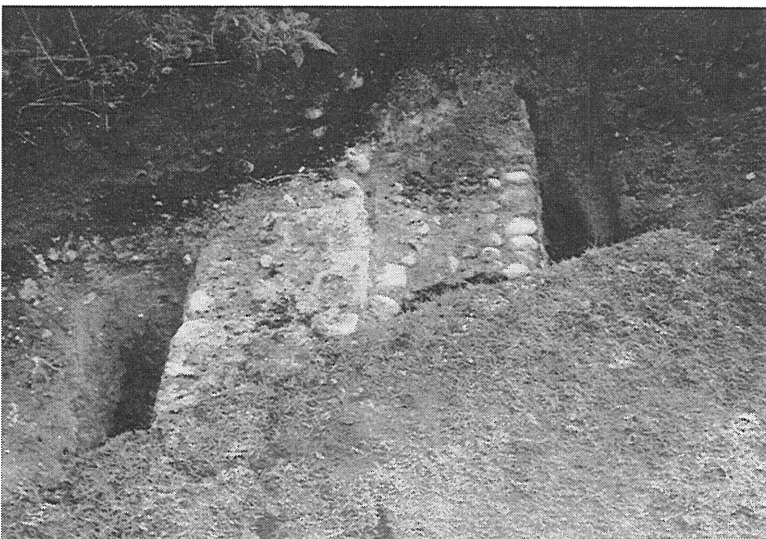
TRENCH 2

Showing the adjoining outer (left) and inner (right) boundary walls

The plan shows that three walls are present. Two of them overlap (and adjoin) in Trench 2, neither quite parallel with the present boundary wall along Leatherpool Lane some two to three metres away. For convenience, the eastern-most wall is here termed the ‘outer’ wall while the western one is the ‘inner’, this being descriptive of their position in relation to the present building. Both walls are of flint – only one fragment of brick was seen in the fabric – and both were c. 55 cm (22 in) wide. The outer wall terminates in Trench 1.

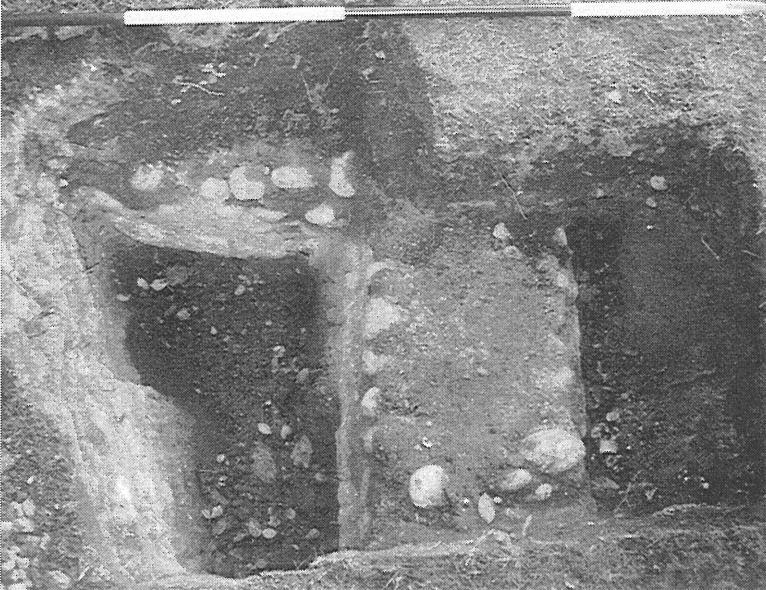
TRENCH 1

Showing the end of the outer wall and the northward continuation of the inner wall

In Trenches 1 and 2 the top of the walls was c. 40-50 cm (16-20 in) below the surface of the lawn and it was evident that both had once been higher. In Trench 1 the inner wall had a ledge on its ‘outer’ (eastern) face, only some 5 cm in width but definite and continuous in character. This ledge lay about 50 cm up from the probable base of the wall. Some further details are shown on the sections below and the general appearance of the walls can be seen in the photographs.

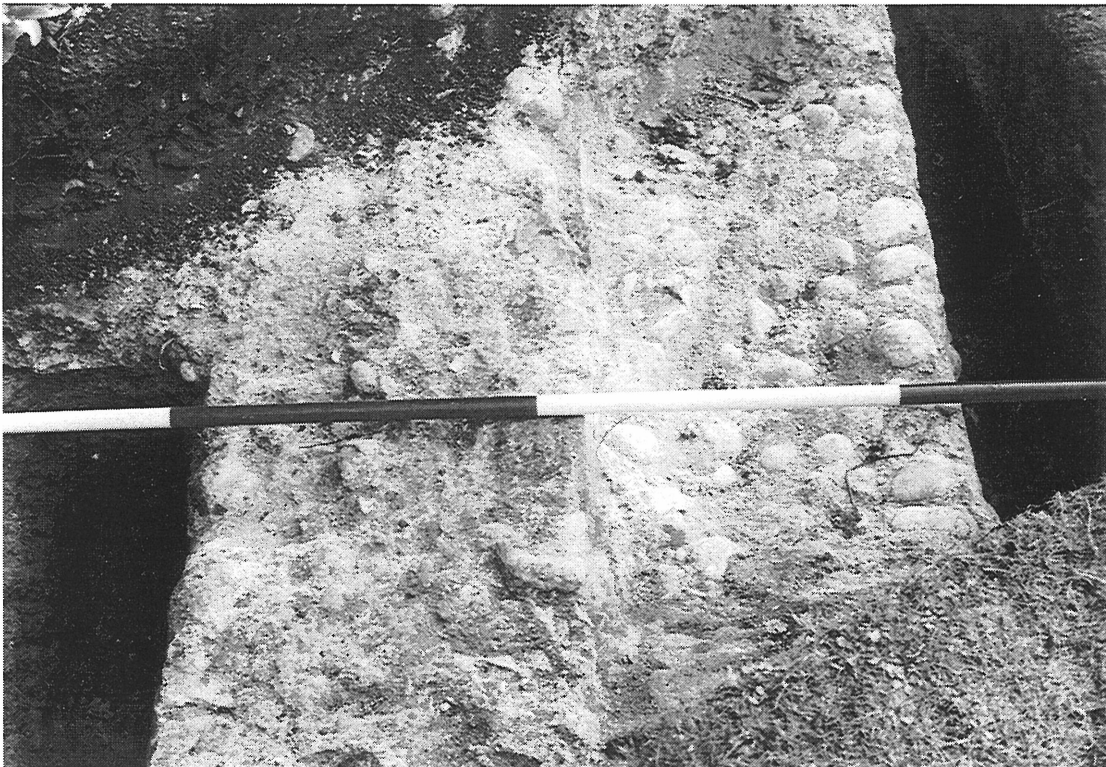
TRENCH 2

**Showing the two walls
in more detail (oblique
and vertical views)**

**The outer wall (left) is
later than the inner
(right) wall**

The overlapping of the two walls suggests that one was built to replace or strengthen a section of an earlier one. If so, which is the earlier? Although the supporting photograph is unclear, a note was made on site to the effect that some stonework in the adjacent walls showed that the outer, eastern, wall was built later and onto the inner one. The two walls differ in character. The inner one contains smaller flints with more regular coursing compared to the outer one with its larger, rougher flints.
