FLINT WALLS: A PRELIMINARY SURVEY OF WALLS IN WIVETON

John F Peake

Flint walls are a striking feature of the landscape bordering the Blakeney Haven, yet there is remarkably little recorded information. This paper explores their distribution in one village, Wiveton, and examines how they were constructed, when were they built and suggests some possible uses, relying primarily on evidence drawn from field observations. Walls have been part of the local landscape since at least the 14th century, but the materials and method of construction means there has been a continuous process of repair and renewal. Nevertheless, they still provide a unique insight into local topography and organisation of the village by, for example, defining old boundaries, demonstrating how the landscape has been modified and indicating the status of selected buildings.

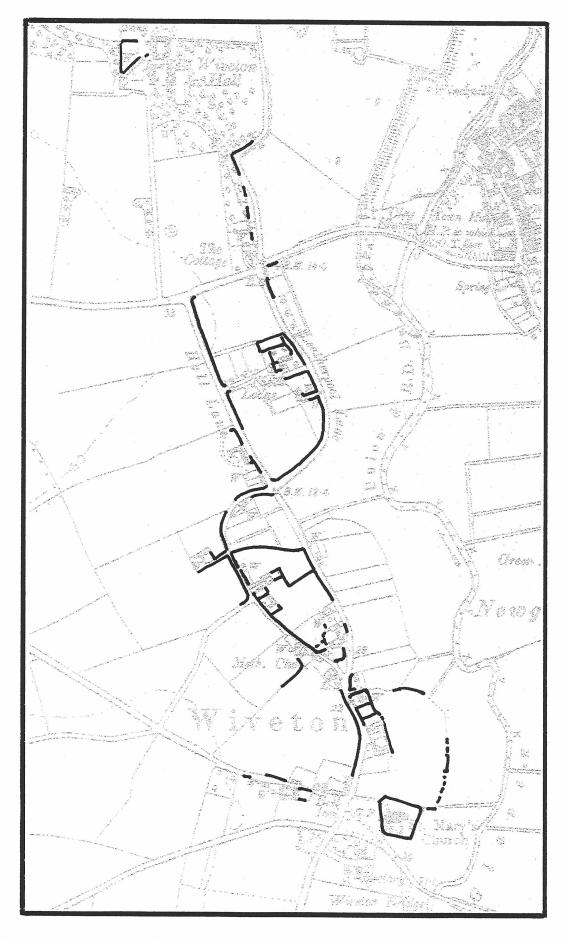
Figure 1 Distribution of flint walls

Solid black line denotes the present distribution of walls in Wiveton. At this scale it is impossible to show many of the shorter lengths of walls and the survey of some areas is still to be completed.

The present distribution of walls is shown on the map (Fig. 1). This clearly demonstrates a north-south axis extending from Wiveton Hall to the Churchyard and an association with habitation and roads, the only extensions being a development in the vicinity of the Church and a wall in the north extending from near Wiveton Hall westwards towards Blakeney. The latter followed the line of a track shown on Faden's map of 1797 and on the much earlier map of 1586.³

Marked on the 1821 Enclosure Map is Creek Road close to the River Glaven and its description in the text of the Award indicates that it was isolated and connected with no other road (see Fig 1). This road appears to be an enigma; what purpose could it have served in such a position, starting nowhere and going nowhere? In the course of the Wiveton study a small hole was dug at this point and at a depth of under 1m flint stones and chalk were discovered. Was it possible that the word 'road' was used loosely for a wide retaining wall

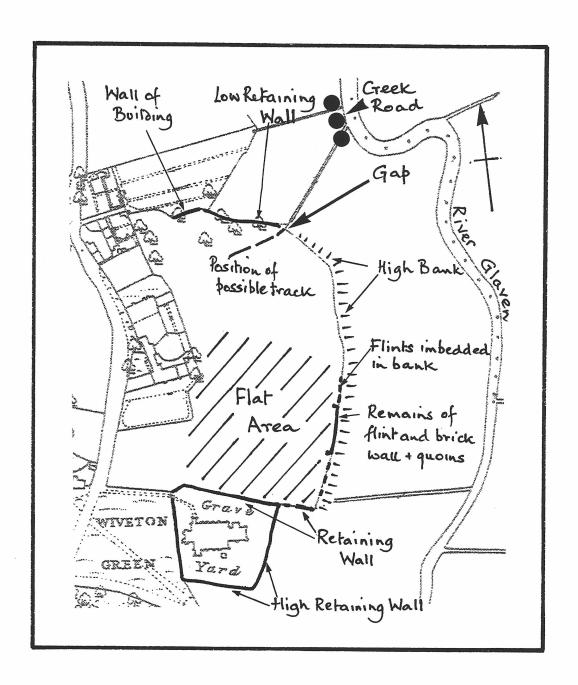
Figure 2 'Wiveton Quay'

Showing the fields known as 'Wiveton Quay' and the position of features referred to in the text.

As indicated earlier the walls at Wiveton Quay (see Fig. 2) exhibit a completely different set of constructional features:

In a few locations walls were built to retain and stabilise banks of soil, but the term landscaped would be more appropriate for the changes around the Church and Church Farm where the local topography has been modified considerably (see Fig. 2). The present Church was built in a strategic position perched on a high bank overlooking the estuary, but the surrounding platform that forms the Churchyard is largely a man-made feature with high walls built on both the east and south sides to retain the soil infill; this is quite apart from the changes in soil level resulting from burials. On the north side the need for additional soil would have been minimal, but even here the lower few courses of the churchyard wall act as a retaining wall. Consequently on three sides the churchyard is raised above the surrounding land surface. To the north the adjacent field known as 'Wiveton Quay' was also landscaped with soil being moved to the south-east corner to extend the comparatively flat area ¹⁷ and this necessitated building another retaining wall at his point.

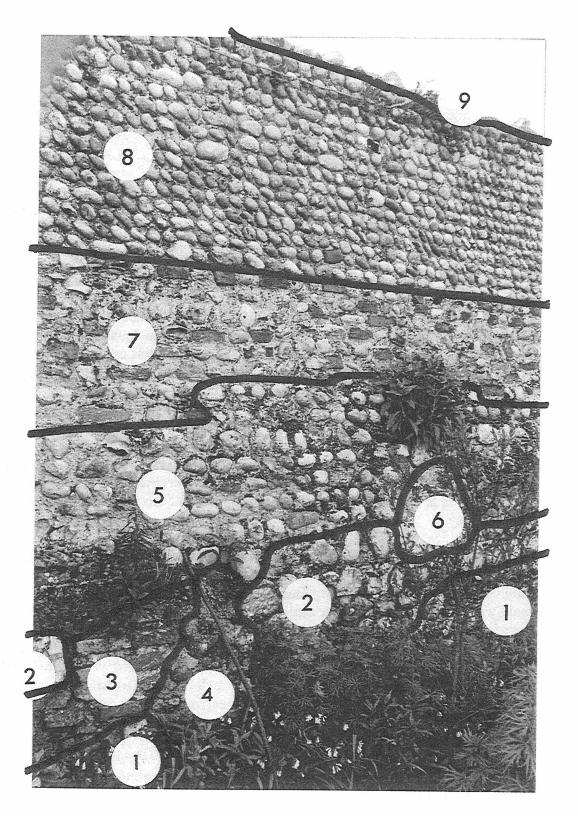
Figure 4 Flint wall complexity

High wall showing a mixture of additions, styles and repairs. Coursing is visible at different levels, with the upper (8 & 9) being probably late 19th or early 20th century additions. At the lower levels little of the base is visible, but there is a mixture of repairs using bricks and flint (levels 3, 4 & 6), and the large knapped flints (level 2) raise issues regarding possible sources of this material.

This is possibly the easiest and at the same time the hardest question to answer, for at the moment there would appear to be no method of ageing flint walls, nor has any documentary evidence been discovered to substantiate the age of any particular wall in Wiveton except for those built in the 20th century. Nevertheless, all the evidence suggests that the life cycle of many walls must have extended over a long time, probably centuries, as they were built, repaired, demolished, rebuilt, and raised to still greater heights (Fig. 4).

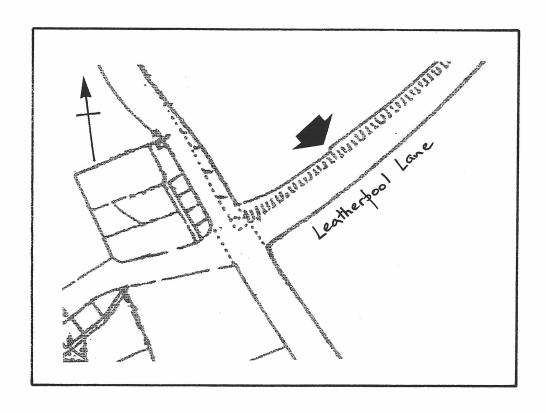
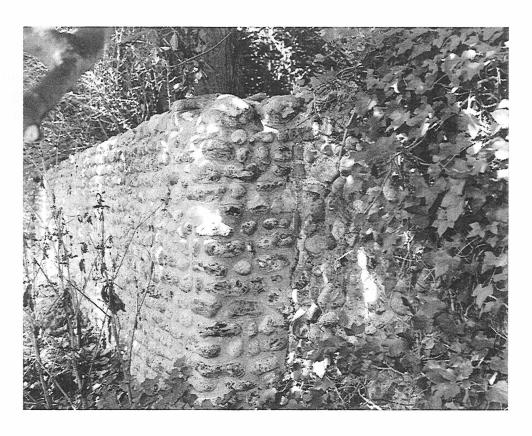
Figure 5 Offset wall

Plan of crossroads at the 'Anchorage' showing position of offset wall along Leatherpool Lane, with photograph looking west.

- iii The boundary wall near the south end of Leatherpool Lane, just before the crossroads at The Anchorage is slightly offset; this is recorded on the first edition of the 25in. Ordnance Survey map produced in 1887 (Fig. 5). Moreover, this wall was rebuilt with the same alignment after it was demolished in the 1953 flood! When such changes in alignment occur in hedges it has been suggested that they reflect variations in a medieval or even earlier field patterns, and the 1821 map accompanying the Parliamentary Enclosure Award for Wiveton shows the boundary of a small field ending at this position.
