BAYFIELD CHURCH : RESISTIVITY SURVEY 1998

By Peter Camell and John Wright

One of the members of the Blakeney Area Historical Society, Dr Peter Carnell, has recently developed an expertise in resistivity surveying and has agreed to help the Society to survey selected local sites. This report records the first such survey and demonstrates that though the actual survey is relatively straightforward, interpretation of the findings is rather more difficult. At Bayfield Church the resistivity readings show various archaeological features which cannot be identified precisely but which provide an excellent focus for further study.

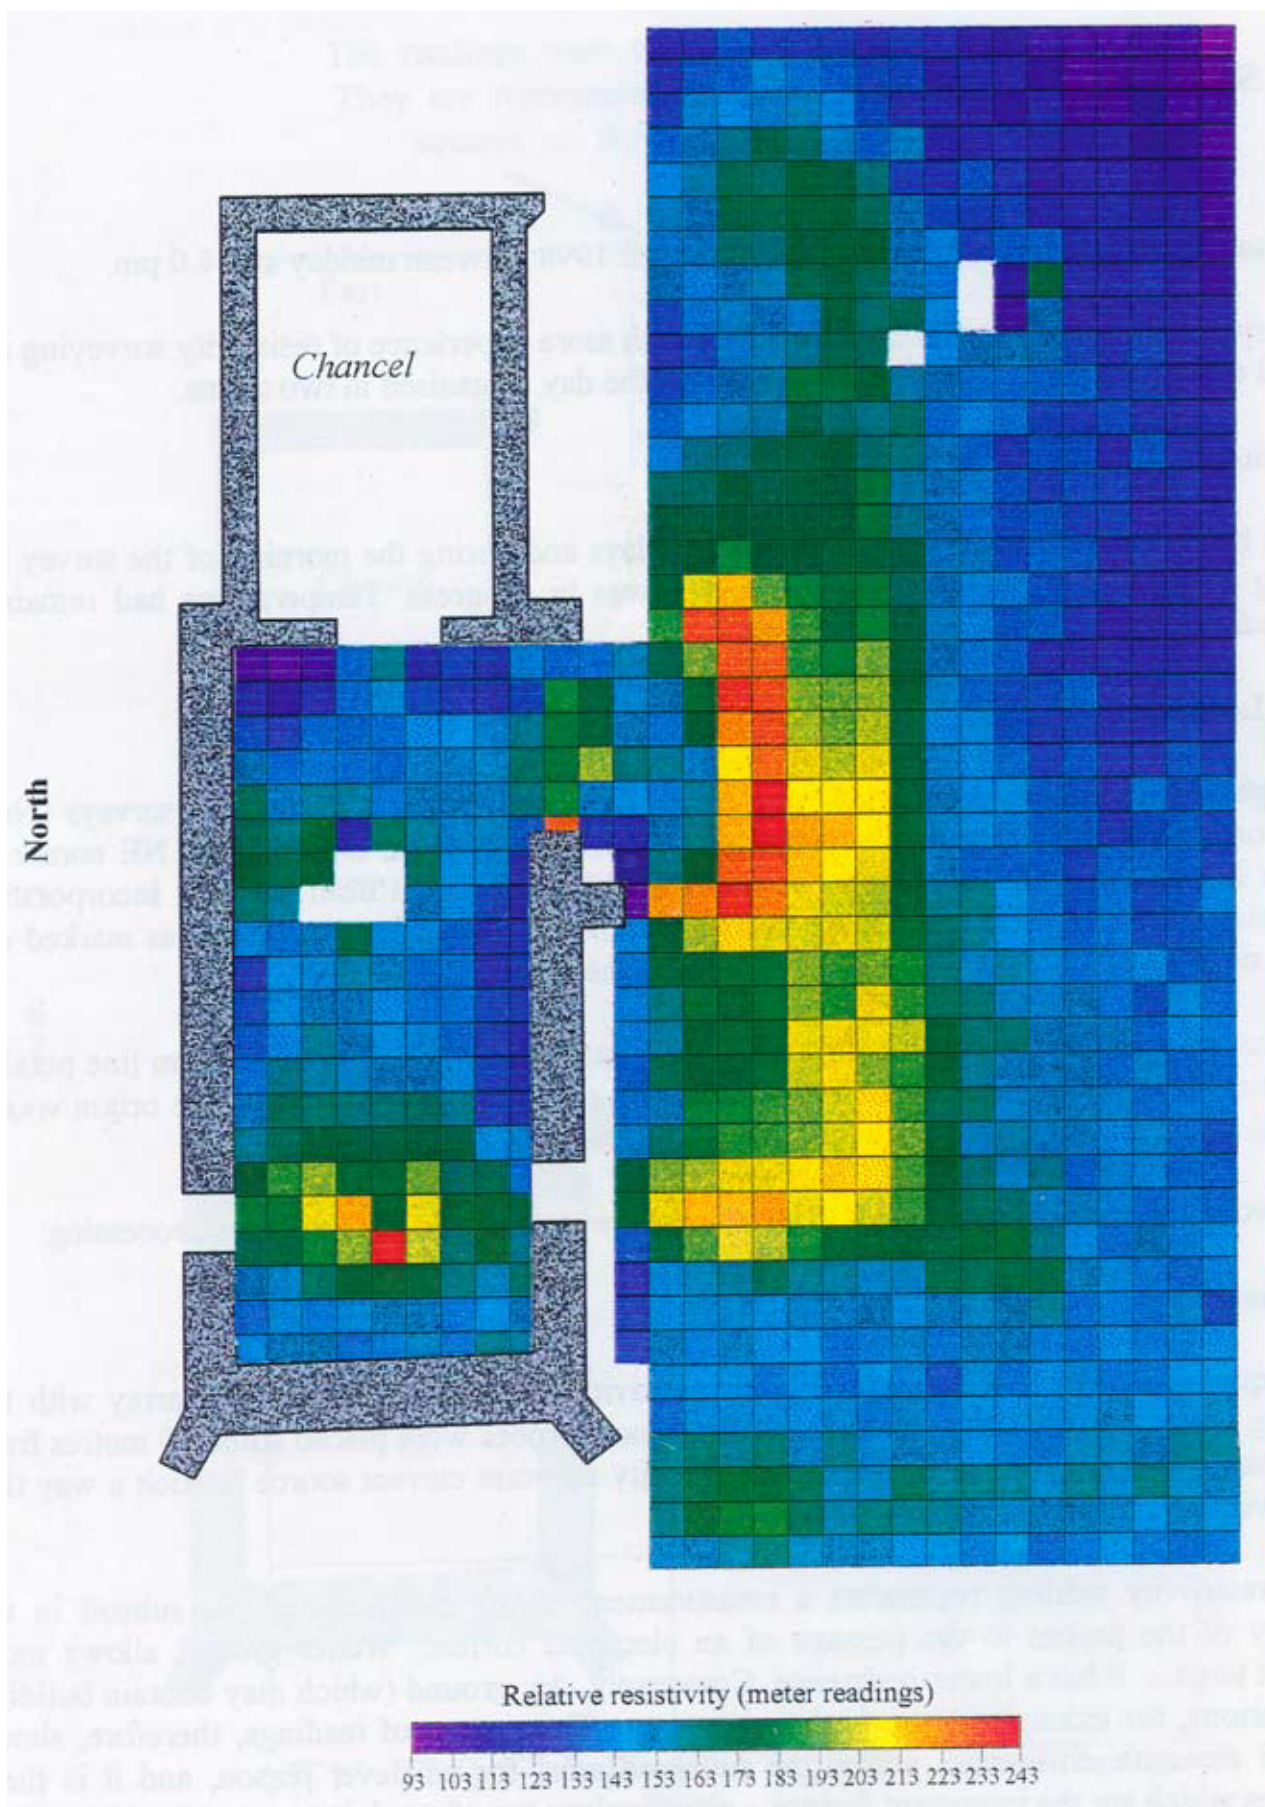
Plan 2, The data as recorded. The colour range, as shown in the key, represents a value range extending from the highest (243) to the lowest (93) recorded.

The plan shows clear patterns in both the Nave and the South Side surveys. The nave is dominated by an area of high resistivity (ie drier conditions) between the two doorways, with the highest values in the middle. A second drier area lies within the larger opening in the nave wall, and a third, less intense, around and to the north of the tree stump.

Outside the church lie two well-defined features. The larger one is an area of dry ground extending 4-5 metres south of the nave, from just beyond the eastern end of the church and westward to the northern doorway of the nave. Within this area the values nearest the nave are generally higher than those opposite the chancel and are particularly high in the vicinity of the opening in the nave south wall. The second feature is a drier area, linear in form and c.1.5m wide, extending North-South just downslope from the present west wall of the church.

In the areas away from these two features there is a steady downward drift in values (ie wetter conditions) towards the South-East.

Elsewhere on the southern side of the church are archaeological features best seen in Plan 2. Although there is a definite pattern it is not clear how many features are present. The most striking is the 'arc' of high readings opposite the gap in the nave wall. The values are the highest on the site and are likely to represent solid material such as brick or flint. The values here are much higher than those clearly indicating the continuation of the nave south wall.

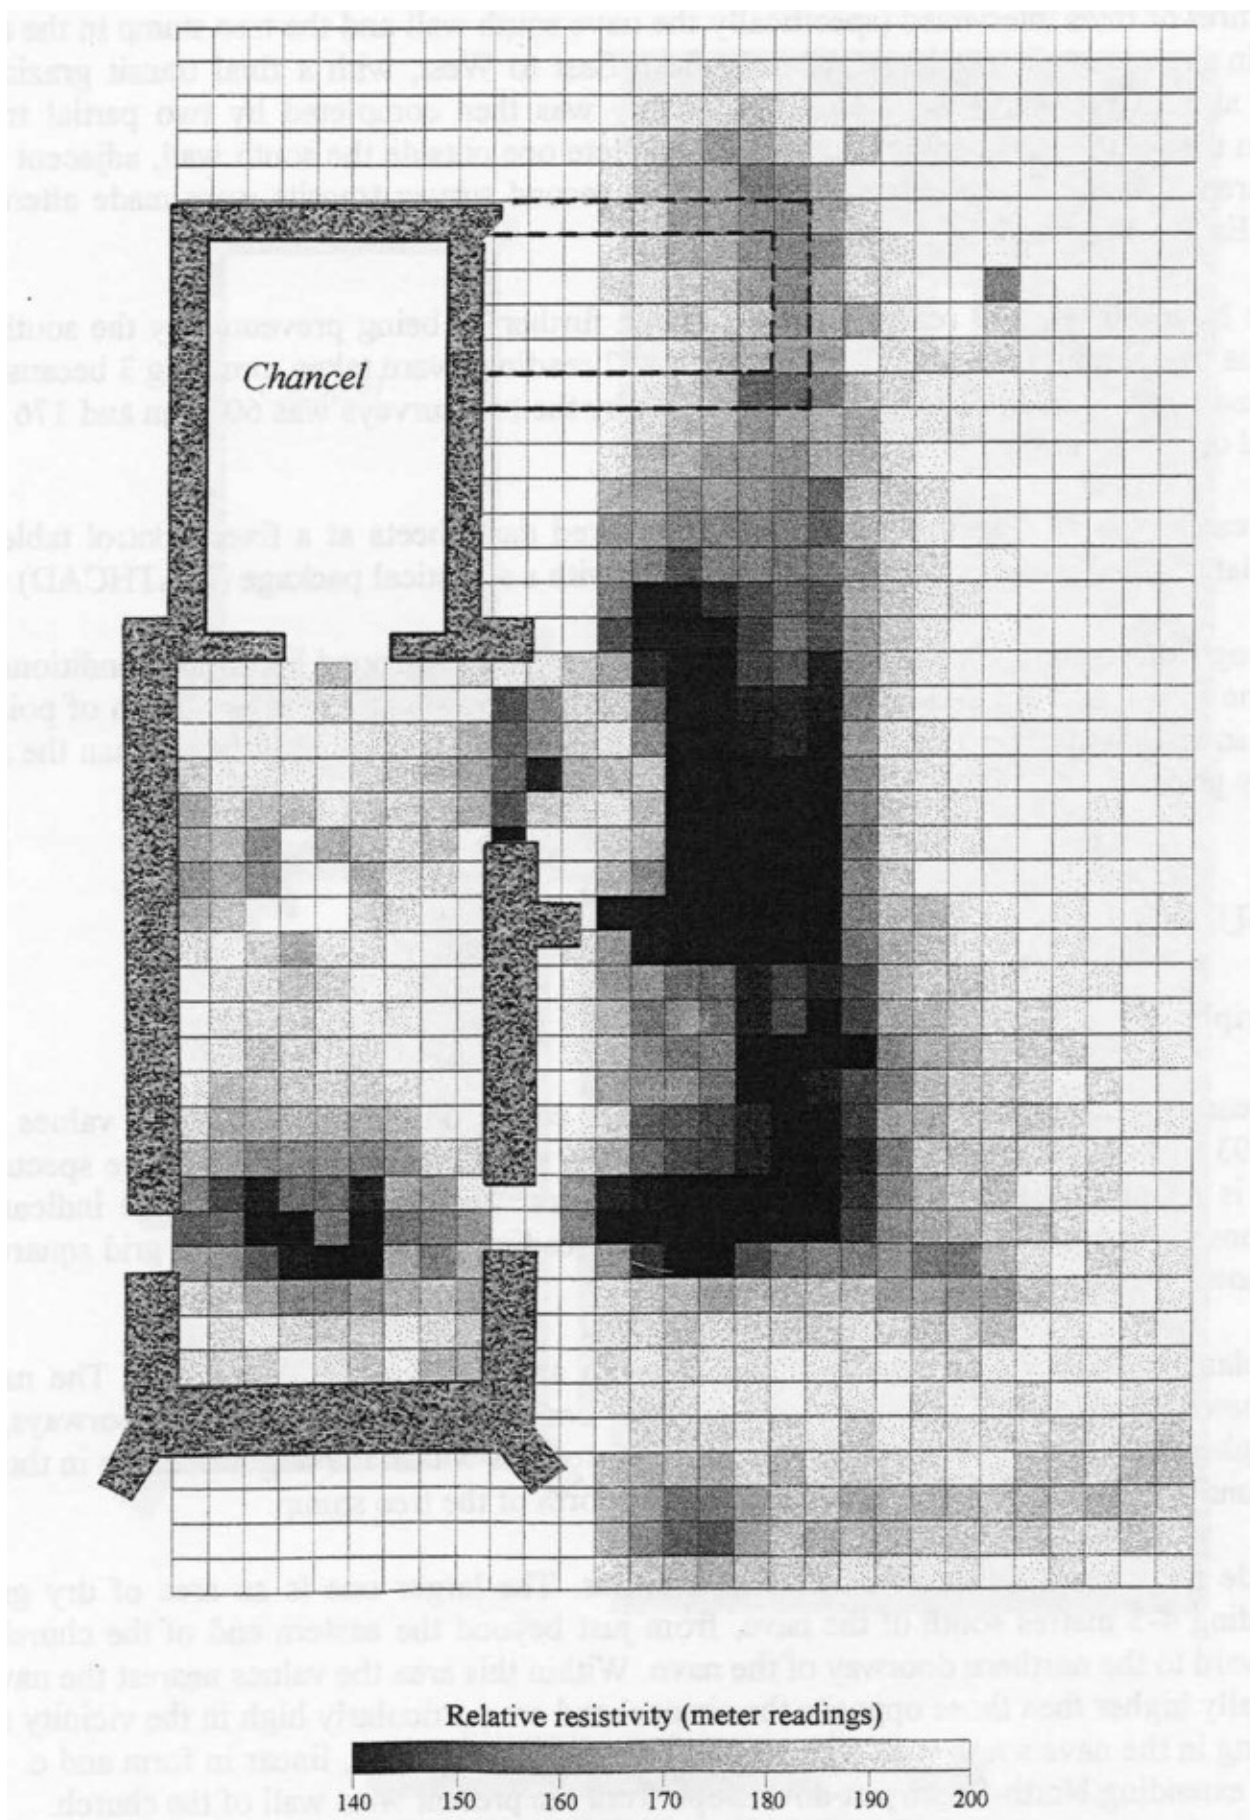
Plan 3. Enhanced data. The grey scale range, as shown in the the key, represents a value range extending from <140 to >200.

However, this apparent 'gap' almost certainly has another interpretation. Plan 3 shows that along the inside of the nave walls are groups of both white (wetter) and darker (drier) squares. The white squares are adjacent to the highest of the remaining walls, while the darker squares adjoin openings or lower sections of walling. The implication is that more rain runs down the higher walls and creates wetter conditions at the base compared with drier ground conditions associated with the lower walls.

The principal objective of the survey was to trace the outline of the suspected chapel on the south side of the chancel. Plan 3 shows that such traces are present but difficult to define. There is a suggestion of an east-west linear feature some 4m from the chancel wall, very close to the limit of the chapel envisaged by Heywood. This could mark the foundations of a wall. Plan 3 suggests the possibility of walls linking this feature to the chancel but the evidence is not clear. Again, the wetter conditions close to the chancel could be masking surviving archaeological features. The possibility of disturbance by tree growth and removal also needs to be taken into account as early photographs show a number of trees close to the church.

A further feature on the south side, showing up most clearly on Plan 3, is the shallow curve just to the west of and downslope from of the church. The appearance is consistent with the remains, or foundations, of a wall, probably buried by the downhill movement of topsoil. In this position it is more likely to be a boundary wall for the church than one associated with landscaping in the park.
